FARNUM
INSPECTION SERVICE

Home Inspection Report

18004 Apple Street, Saratoga, CA 95070

Electrical System

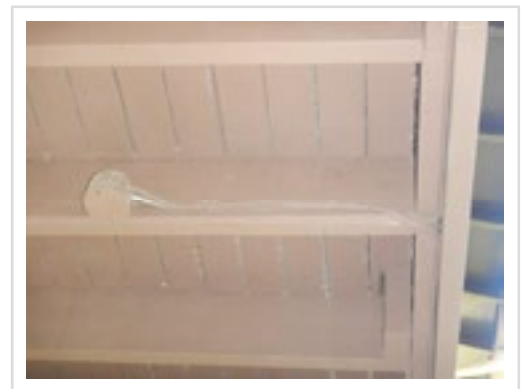
- 28

**REPAIR** The junction boxes at the east exterior wall below the balcony are not rated for exterior use and should be replaced. The use of properly rated waterproof junction boxes on the exterior are required to prevent moisture intrusion into the electrical connections. Repairs to correct this condition are recommended.

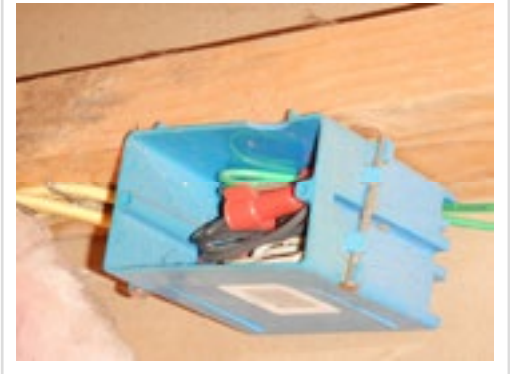
- 29

**REPAIR** An electrical junction box located in the attic is missing its cover plate. All junction boxes should be fitted with cover plates in order to protect the wire connections from accidental damage. Repair to install a cover plate at this location is recommended.

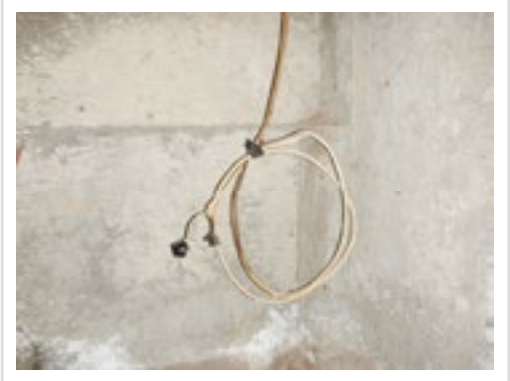
- 30

**SAFETY ISSUE** An abandoned and improperly terminated electrical cable was found. The exposed conductor presents a risk of electrical shock. **This condition presents a safety hazard and requires corrective action to reduce the potential for injury.** Electrical wiring not in use should be removed and/or properly terminated in a sealed junction box. Further evaluation and repair by a qualified electrical contractor are recommended.

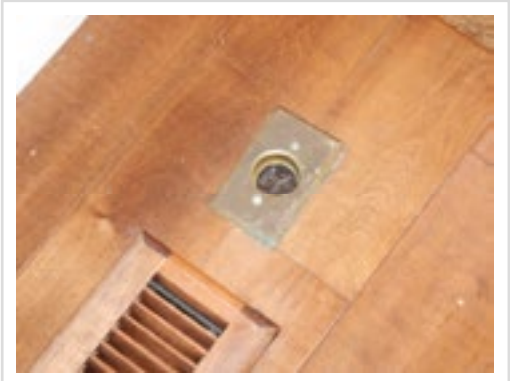
- 33

**REPAIR** One of the receptacle outlets at the east exterior wall and at the stairway appears to be miss-wired and tested as 'ungrounded'. A grounded wiring system was present in the home. Receptacles of this type require a ground connection to function as intended. Evaluation and repair as needed by a qualified electrical contractor is recommended.
